**Lind Point Housing and Resource
Management and Science Facility**
Earth Change Plan /
Environmental Assessment Report

United States Virgin Islands
Department Of Planning And Natural Resources
Major Land Development Application

National Park Service
Virgin Islands National Park

Stantec Consulting Services Inc.

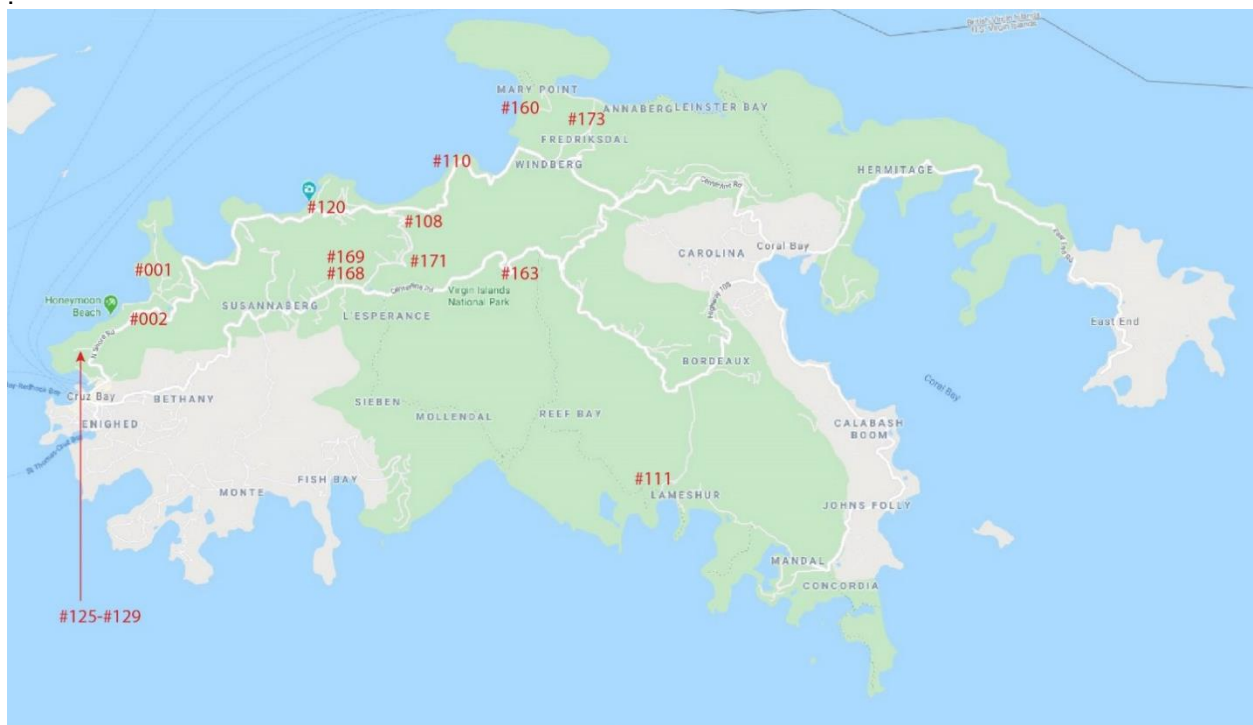
Existing Housing Locations

Lind Point contains 5 existing duplex buildings running the length of the road east-west, an office cluster of 4 buildings (biosphere) and a storage building on the north side of the road at the western most point. The biosphere buildings were damaged and deemed structurally unsound by the hurricanes in 2017 and will be removed prior to this project. The storage building demolition is included in this project scope.

The proposed project is rebuilding the office type on the north side and adding 3 additional housing structures that are replacing the following homes: Montequ (#163), Callahan (#168), Lyne House Apartment (#002), Trunk Bay (#120), Lily Maho (#160), and Island Fancy (#173), and Lameshur (#111), which were also destroyed in hurricanes Irma and Maria.

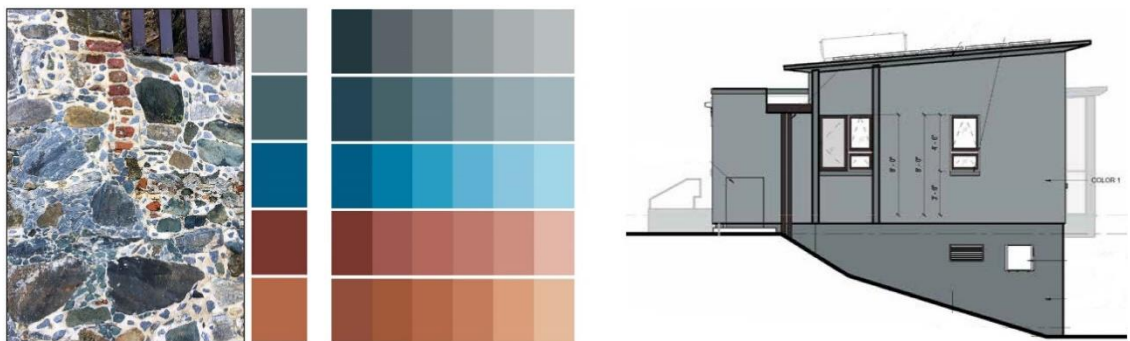
Figure 9 – Color Investigation and Elevation Studies

Maintenance of scenic views of natural landscapes of green mountains and tropical vegetation from the beaches and from the water will likely be impacted by this development. The design team is intending on mitigating the impact using a variety of effects with landscaping, natural colors pulled from the island, and building orientation to align with the slope of the site.

- Design team is minimizing the height of the walls and floors, utilizing the natural slope of the site to orient the buildings and allow for a single height space on the entry side.
- Design team is utilizing a low slope roof to assist in minimizing the vertical construction required to shed water. These roofs will either be behind parapets or sloped away from the beach & bay to minimize its visual appearance.
- Design team is investigating natural color schemes to help blend in with the vegetation.
